WHITING POND DAM
MA 00859

PHASE I INSPECTION REPORT
NATIONAL DAM INSPECTION PROGRAM

DEPARTMENT OF THE ARMY
NEW ENGLAND DIVISION, CORPS OF ENGINEERS
WALTHAM, MASS. 02154

DECEMBER 1978

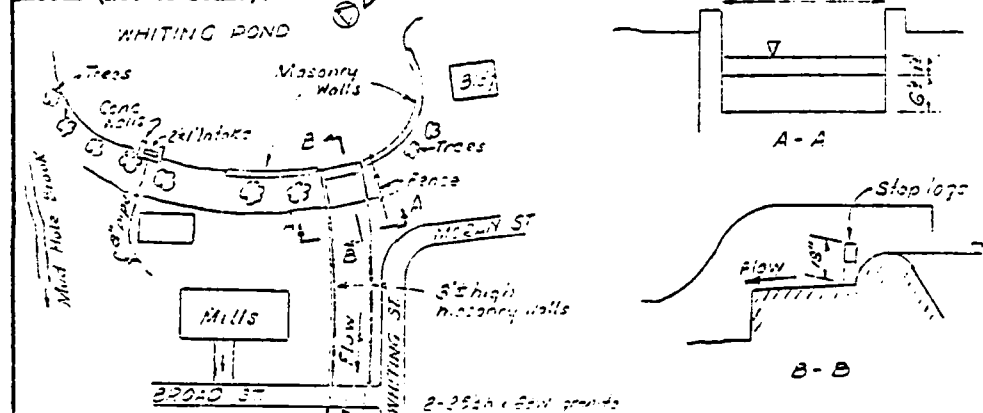
Sketch (Not to Scale):

Remarks and Recommendations: Sanitation Department must at present siphon off high water - grossly inadequate discharge provisions. Overtopping was reportedly avoided in 1955 by placing canbirs on embankment. Same damage, however, from flooding of Mud Hole Brook on south side of mill. Great damage potential if embankment is overtopped in flood.

Discharge inadequate. Recommend provision of wider, deeper spillway and gate.
